Durability of Galvanized Steel Framing in Residential Buildings

Summary of a ten year report produced by NAHB Research Center, a subsidiary of the National Association of Home Builders (NAHB) in the US and sponsored by International Zinc Association

OVERVIEW

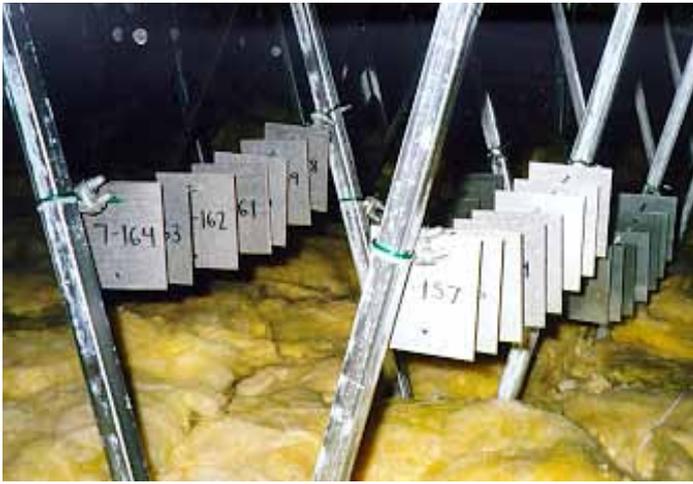
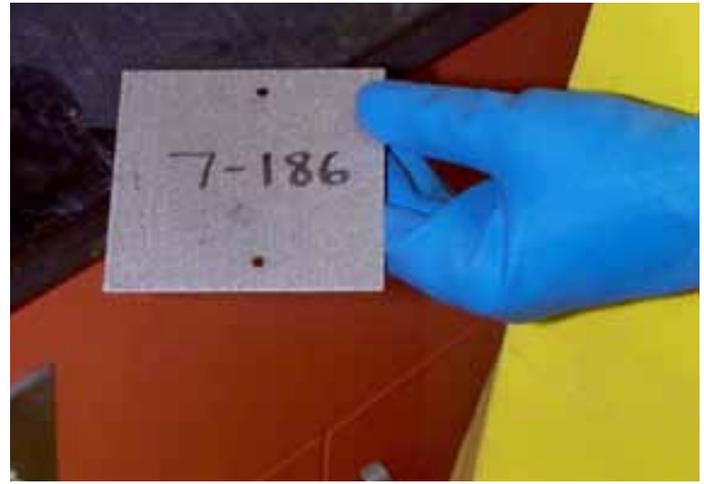
Figure 1 – Plate Samples

of the specimen's area, and thus a more accurate measure of coating corrosion rates calculated from mass reduction of the samples after exposure (Figure 1). The C-section samples were installed to investigate corrosion performance at the edges and bends of a stud. Both the plate and stud samples had both sides and all edges exposed. The coating thickness specifications and measured coating weights of the samples are listed in Table 2. Coating Thickness (column 5) is the calculated coating thickness based on the measured coating mass in column 4. Coating tests performed per ASTM A90/A90M¹ determined that actual coating masses (column 4) were all above the minimum specification requirements. Samples were installed to allow for analysis after one, three, five, seven, and ten years of exposure. An overview of where samples were installed in the four sites is provided in Table 3.

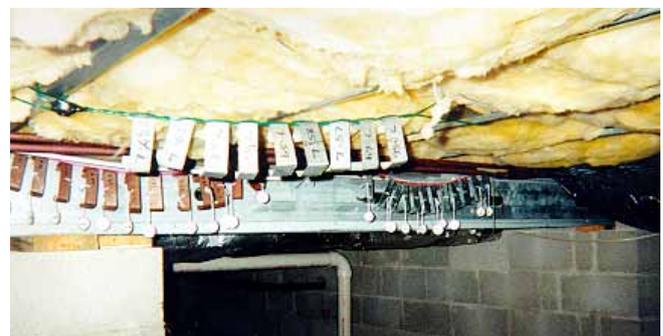
Specimens were installed in the attic, an exterior wall, the crawl space, and under the outdoor deck. The crawlspace contained a set of suspended samples fully exposed to the ambient crawlspace environment, including bare (stripped) stud-type specimens. The bare samples displayed extensive corrosion after just two months of exposure, indicating the aggressive environment in the crawlspace (see Figure 5). Specimens were also installed under an outdoor deck, which represented

Figure 5 - Stud specimens in Leonardtown Site crawlspace. Note the uncoated C-sections in the background show red rust after just two months of exposure.
