Durability of Galvanized Steel Framing in Residential Buildings

Summary of a ten year report produced by NAHB Research Center, a subsidiary of the National Association of Home Builders (NAHB) in the US and sponsored by International Zinc Association

OVERVIEW

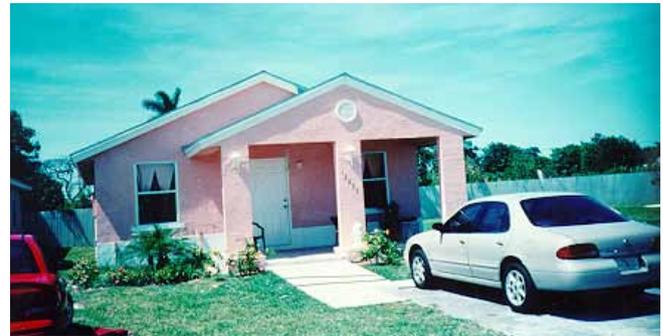
Figure 2 - Miami, Florida Corrosion Site

The Miami site (Figure 2) was in a Habitat for Humanity Development in southwest Miami, where 16 of the 90 homes were framed with steel systems. The site was a single-story steel framed structure with a slab on grade foundation. It had plywood sheathing with a stucco exterior finish. The wall interior was 5/8 in. (16 mm) painted drywall. The attic was kraft faced (facing the drywall) R-30 fiberglass batt insulation, while the walls have either R-11 or R-13 batts. The walls were 6 in. (152 mm) wide. The attic was vented with soffit vents [19 vents total, each is 22 in. x 4 in. (56 cm x 20.5 cm)]. No ridge vents were present, and one small gable end vent was visible in the front of the house.

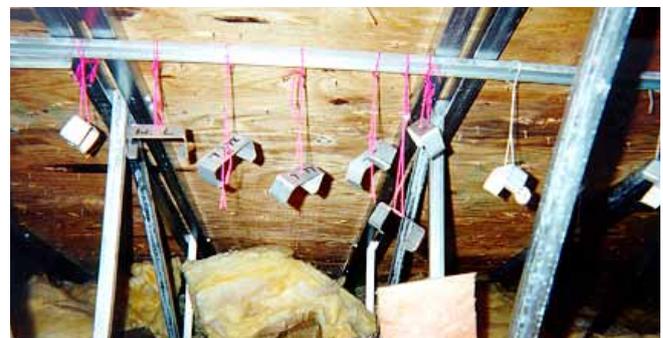
Figure 3 - Attic Specimens in Miami, Florida Site

Sample colonies were located in both the attic (see Figure 3) and an exterior wall. The attic colony samples were suspended from the roof framing. The attic was vented by soffit vents on the east and west sides of the house. The wall cavity colony had a west-facing exposure, and contained samples which were accessible for retrieval through access panels. The samples were embedded into the fiberglass batt insulation in the wall cavity.

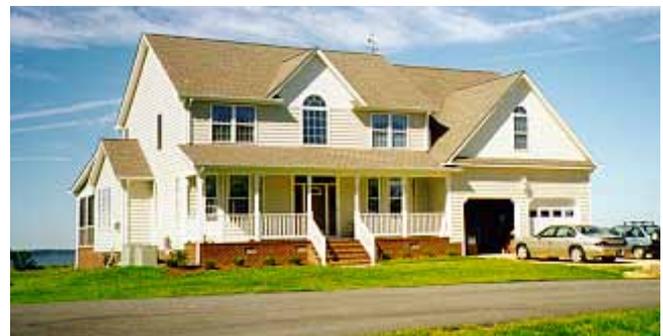
Figure 4 - Leonardtown, Maryland, Site on lower Potomac River

The Leonardtown, Maryland, house (Figure 4) was on the lower Potomac River before it empties into the Chesapeake Bay. The two-story home was roughly 75 feet (23 m) from the river, with strong winds often blowing spray towards the house from the brackish river water. The walls were framed with 0.043 in. (1.1 mm) thick steel C-section studs, while steel trusses were used for the roof framing. Steel floor joists were used in the crawlspace along with R-19 fiberglass batts. A layer of poly was installed on the crawlspace floor. The attic was insulated with 11 in. (28 cm) of blown cellulose and vented with a ridge vent and soffit vents. The walls consisted of 5/8 in. (16 mm) drywall, wet-blown cellulose (R-13), OSB sheathing, 1 in. (25 mm) of non-foil faced foam cladding (R-5), an air infiltration barrier, and vinyl siding. All bathrooms were vented directly to the outside. The foundation was vented with perimeter vents in the block wall.

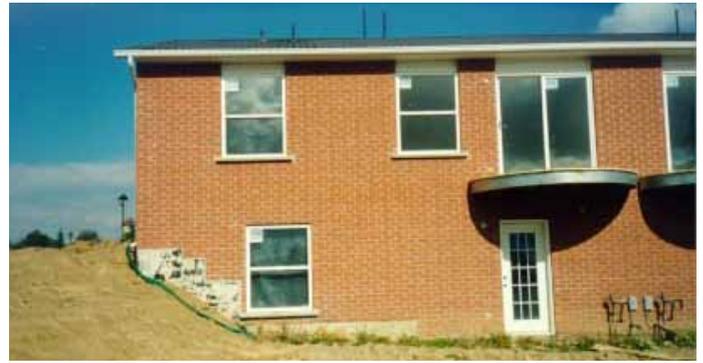
Figure 6 - Hamilton, Ontario Test Site (Rear View)

The Hamilton, Ontario, house (Figures 6 and 7) was a 2-storey townhouse block built on a concrete floor slab in a retirement community. It was the end unit, with a walkout on the ground floor. Three of the four walls were concrete block, with the fourth wall (east facing) being steel-framed. The framed walls were designed as follows: interior wall covering was 5/8 in. (15 mm) drywall, behind which a poly vapor barrier was installed. The walls were insulated with R-13 fiberglass batts. Beyond the framing was 1-1/4 in. (32 mm) of foam sheathing (R-7). Outside of the foam sheathing was a 1 in. (25.4 mm) air gap, with a brick veneer finish beyond this.

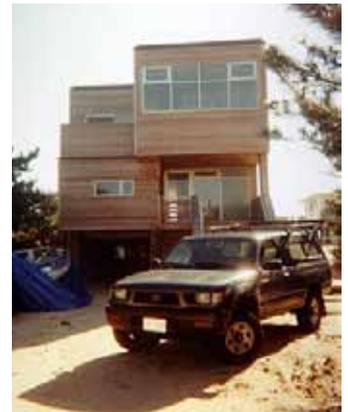
Figure 8 - New Jersey Site

The Long Beach Island, New Jersey site (Figure 8) was the last addition to the research study with specimens being installed in 1998. The site was a beachfront house on the New Jersey shore, and was separated from the ocean by a low-lying dune roughly 1/4 mile (400 m) wide. The house was originally a one-story structure, and was remodeled to include a new second floor and roof that were both framed with cold-formed steel (Figure 9). The house was occupied primarily during the summer season, and was left vacant during the winter.

Three sample colonies were established in the New Jersey site. The first was a full set of stud and plate samples located between the joists that supported the first story. This location should carry some risk of corrosive conditions because it was not immune to infiltration air and outdoor conditions. The second colony was located on a cantilevered deck that hung off the second story of the home and faced the beach (Figure 9). The joist bays under the deck were vented, which presented an opportunity for ocean breezes to deposit salt
